# SCHAP<sup>®</sup>

## H2 MANNIKIN REPAIR

HUMANETICS  
JASTI

REPAIR  
> PELVIS  
> LEGS  
> KNEES  
ILD RATING

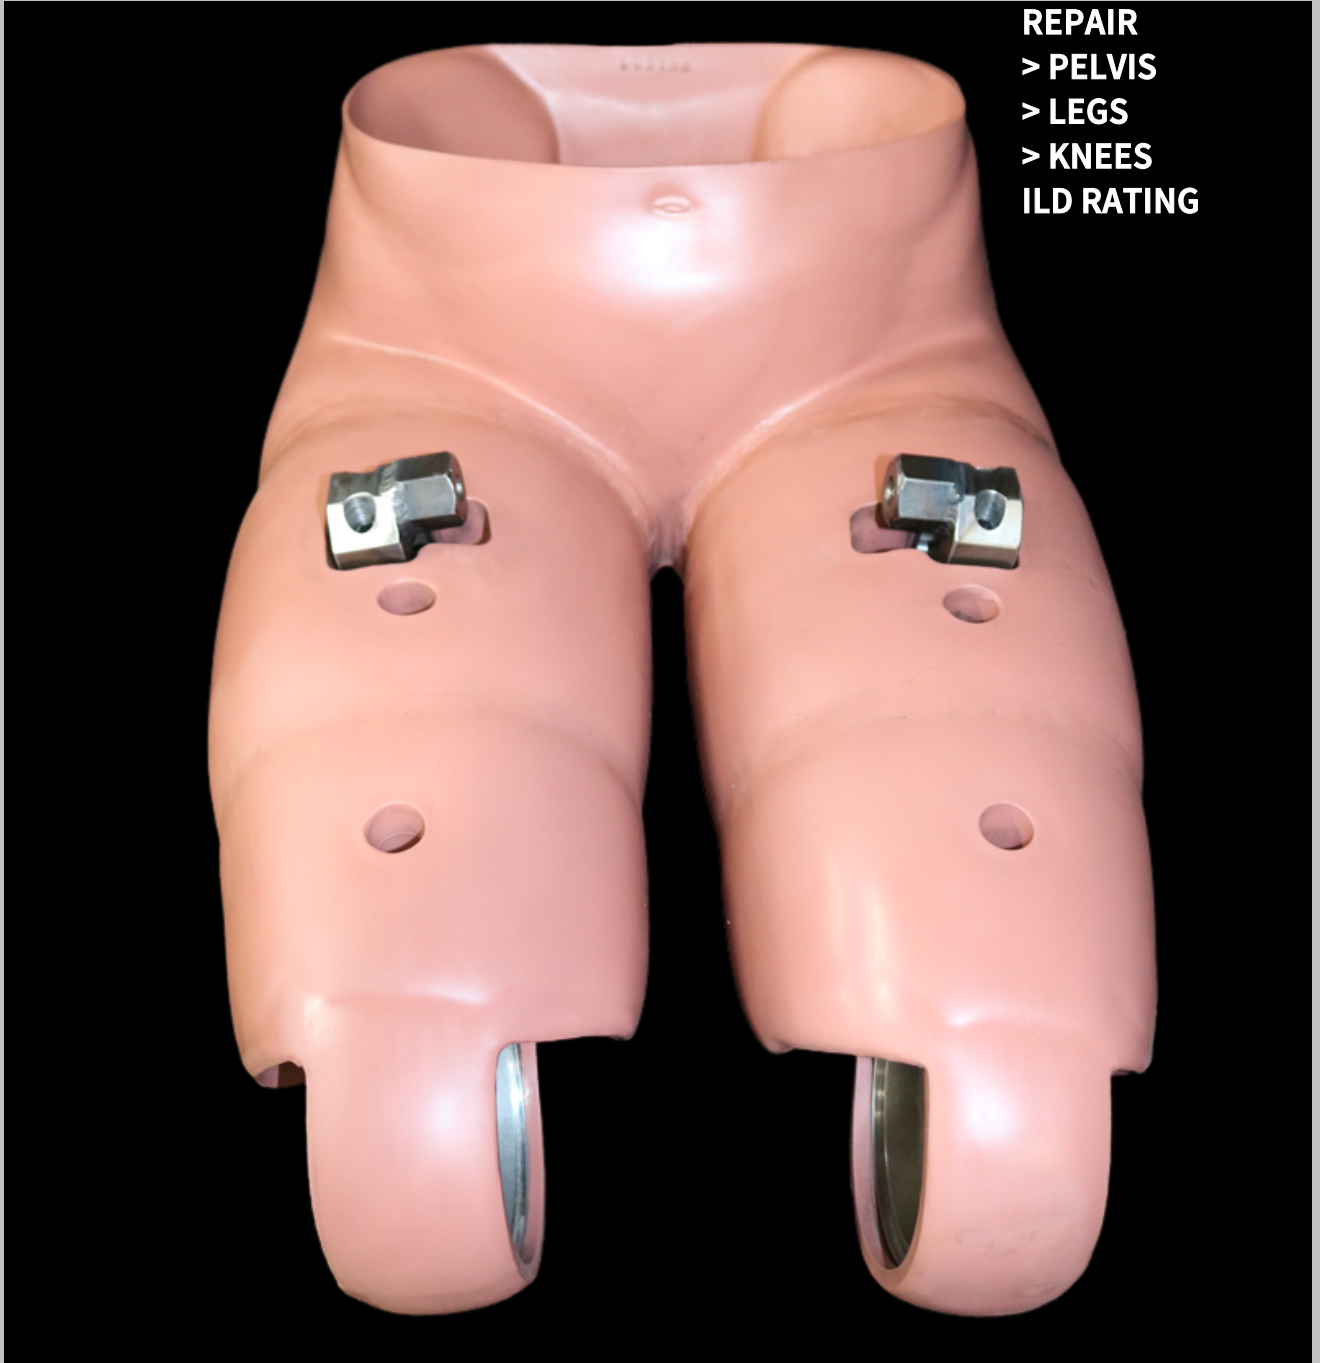
REPAIR OR REPLACE PELVIS, LEGS, KNEES, HIP JOINTS

REPAIR FLESH THAT HAS TORN, INCLUDING WELDED JOINTS USING 3-LAYER WELDS

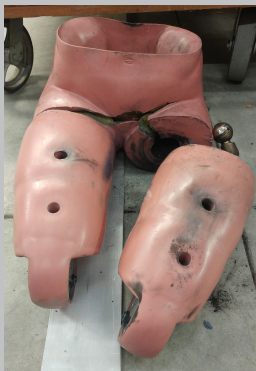
## INSPECTION REPORT

- Pelvis - torn from left to right crotch
- Left Leg - hip joint worn to failure, torn joint to pelvis.
- Right Leg - fair condition, torn from pelvis
- Left Knee - good condition
- Right Knee - good condition
- ILD Results - 40% life remaining in pelvis

Our experience repairing H2 Mannikins is to your benefit. Extending the life of this important body form drives to the bottom line. Repair costs are a fraction of the cost of a new form. Schap inspects the flesh for tears, internal hip joints for wear, and ILD tests the form for the life of the internal foam. Only Schap fuses the flesh between the pelvis, legs, and knees, to produce a surface without joints. The triple-welding technique is stronger than the surrounding flesh, an effective method of making the forms last longer.
